## CALSPAN AIR BAG DEPLOYMENT INVESTIGATION

CALSPAN CASE NO. CA96-13

VEHICLE #1 - 1996 SATURN SW2 WAGON VEHICLE #2 - 1991 MITSUBISHI ECLIPSE

LOCATION - STATE OF GEORGIA

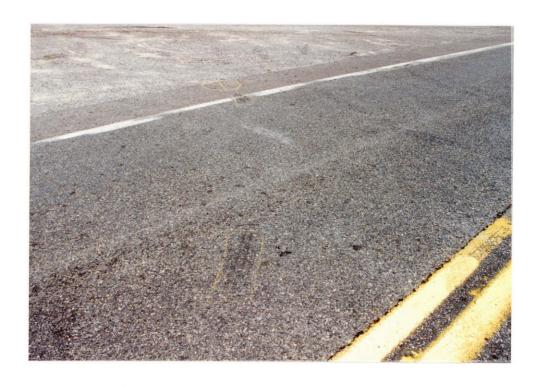
As Vehicle #1 initiated the left turn, Driver #2 attempted to avoid the crash by braking and steering to the right. Vehicle #2 departed the right side of the roadway and traveled across the northbound intersecting travel lane adjacent to the intersection boundary. Tire skid marks noted at the scene indicated Driver #1 observed the approach of Vehicle #2 and applied full brakes to avoid the crash (refer to photograph #8 on page A-4).

8. View showing pre-impact skid marks from Vehicle #1. This view also highlights Vehicle #1's final rest position (FRP).

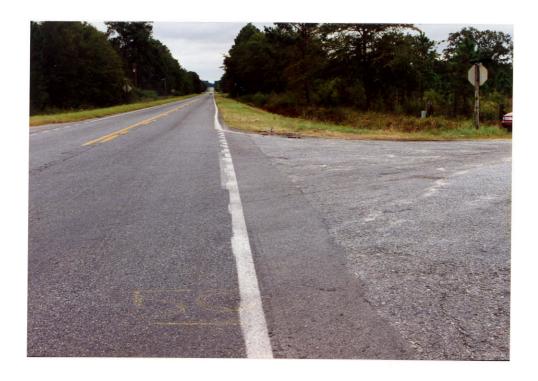
18. Pre-crash trajectory of Vehicle #2 - 15 meters (50 ft.) prior to the POI showing the crash avoidance path toward the right shoulder of the roadway.

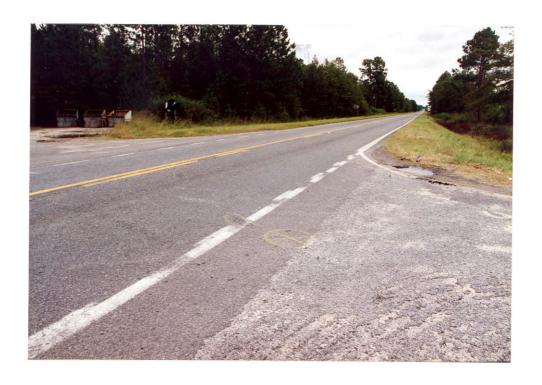
20. View of the POI.

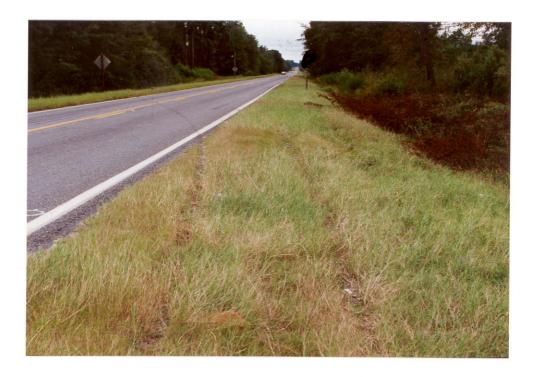
24. View of Vehicle #2's right front and right rear tire marks in the grass along the south shoulder.

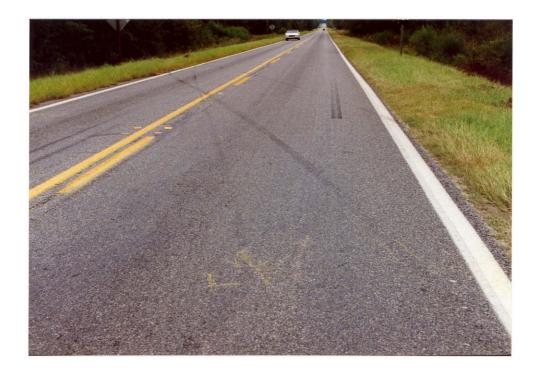
26. Vehicle #2's skid marks crossing the roadway toward the north shoulder.

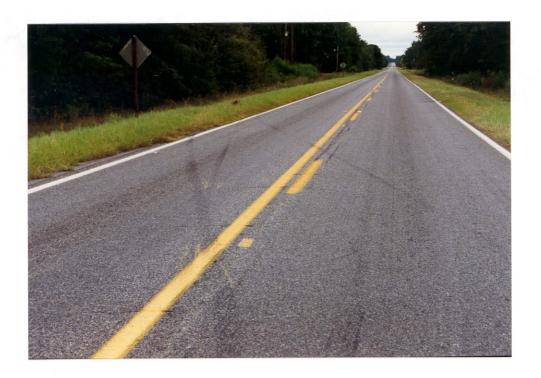
27. View of the right front and left rear tire crossover marks as Vehicle #2 rotated counterclockwise.

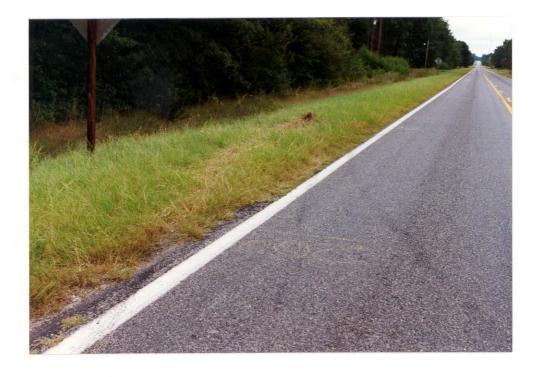
28. View of the skid marks leaving the roadway onto the north shoulder.

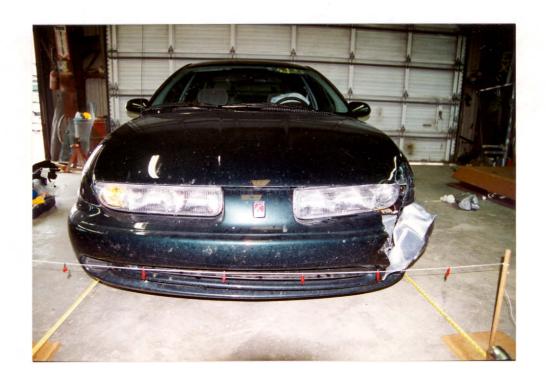
Vehicle #1 sustained direct contact damage 30 cm (12") wide on the left front bumper. The maximum rearward displacement of the front bumper was 9.1 cm (3.6") located at the left front corner. The CDC for this impact was 01-FLEE-1.

The left front bumper of the 1996 Saturn Wagon (Vehicle #1) struck the left side plane of the 1991 Mitsubishi Eclipse (Vehicle #2). Vehicle #1 sustained direct contact damage to the front bumper starting 38.1 cm (15.0") left of the vehicle centerline and extending 30.5 cm (12.0") to the left corner of the bumper. The front bumper sustained a maximum rearward displacement of 9.1 cm (3.6"). Measured crush values along the front bumper are listed below:

Components damaged in the crash included: the front bumper fascia; the hood; the left front fender; and windshield.

37. Overall view of the 1996 Saturn SLT's frontal plane.

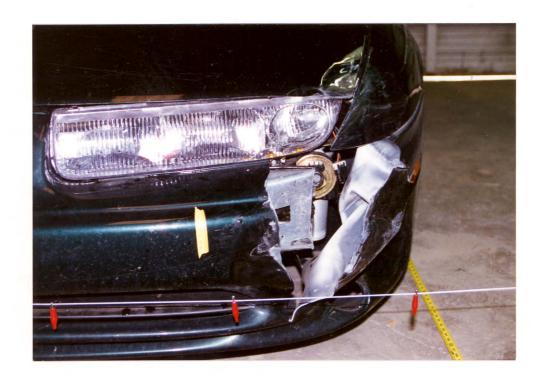
38. View of the left frontal plane.

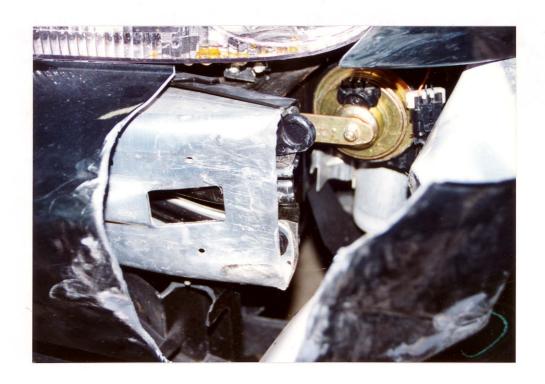
39. Close-up view of the left side bumper reinforcement bar.

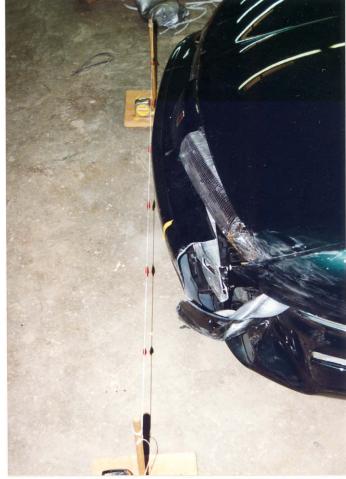
42. Lateral view showing rearward displacement of the left front corner.

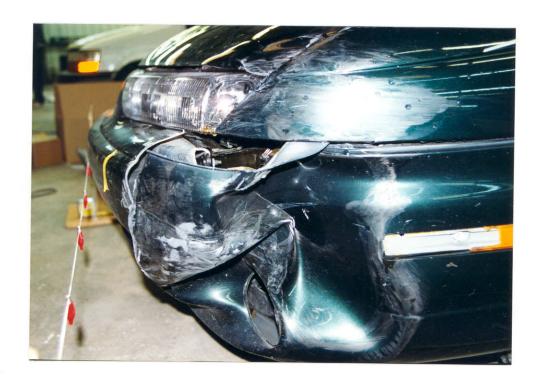
43. Lateral view of the left front fender of Vehicle #1.

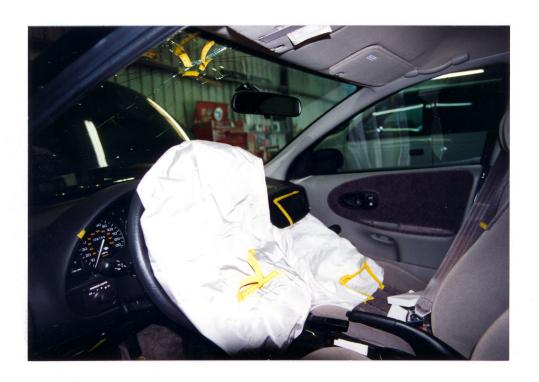
52. Angular view of the driver's side windshield, instrument panel and air bag module showing contact evidence.

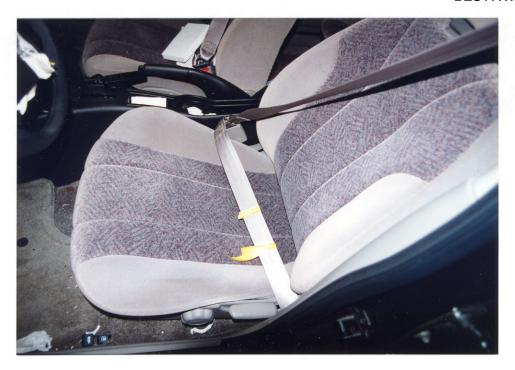
53. View of the driver's seat with yellow tape marking the location of an abraded surface on the lap belt.

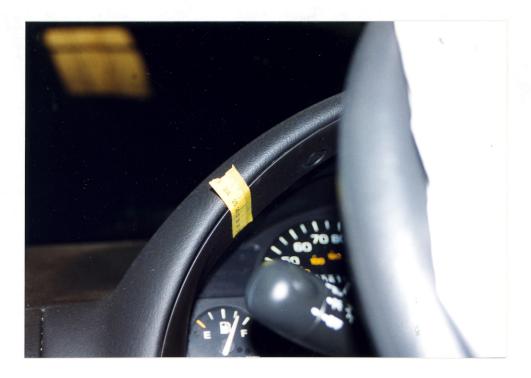
55. Close-up view of a scuff mark on the left side of the instrument panel eyebrow.

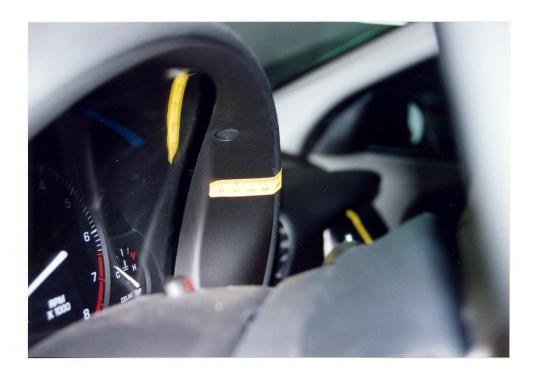
56. Close-up view of a scuff mark on the right side of the instrument panel eyebrow.

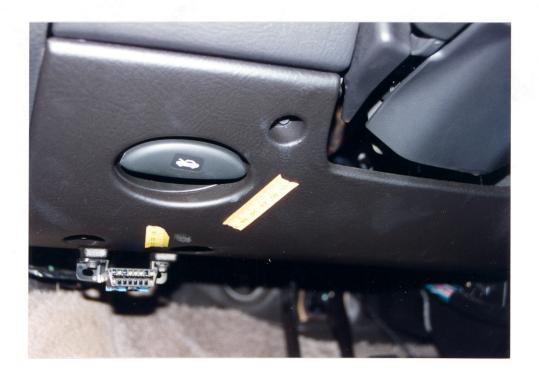
57. Close-up view of scuff marks on the left knee bolster.

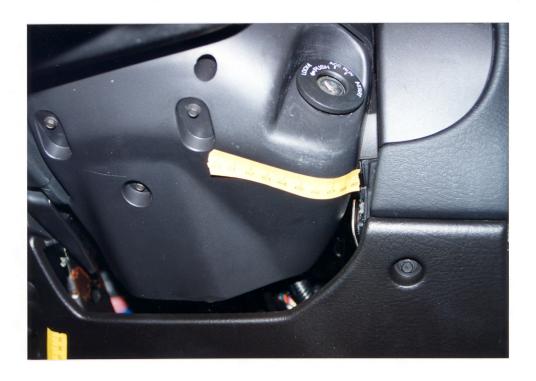
58. Close-up view of scuff marks located on the right side of the steering column.

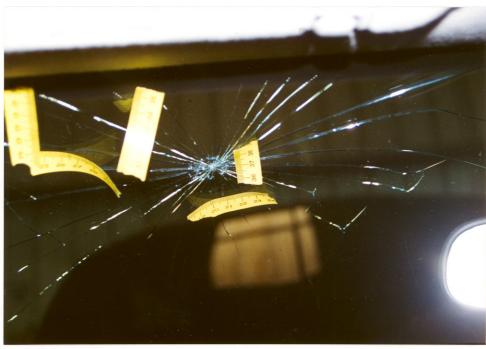
The windshield exhibited two separate spider web type fractures which were attributed to driver contact. The first fracture was located 8.3 cm (3.25") below the windshield header and 43.8 cm (17.25") left of the vehicle centerline. A light smudge mark over the fracture site was attributed to contact by the driver's left hand. The second was located 27.9 cm (11.0") left of the vehicle centerline and 8.9 cm (3.5") down from the windshield header. A light smudge mark was also noted in the vicinity of the fracture which was attributed to contact by the driver's right hand.

61. Close-up view of a small spider web glazing crack located at the upper left corner of the windshield.

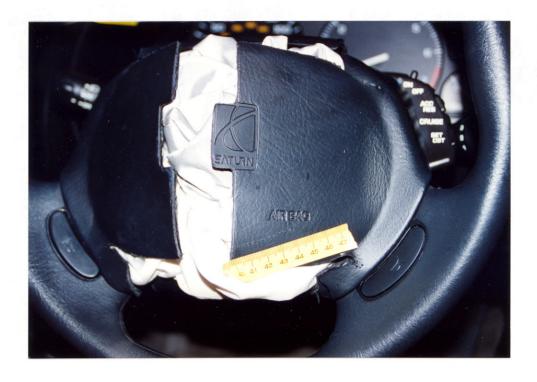
65. Close-up view of the driver side air bag module right cover flap showing a scratch mark near the bottom edge.

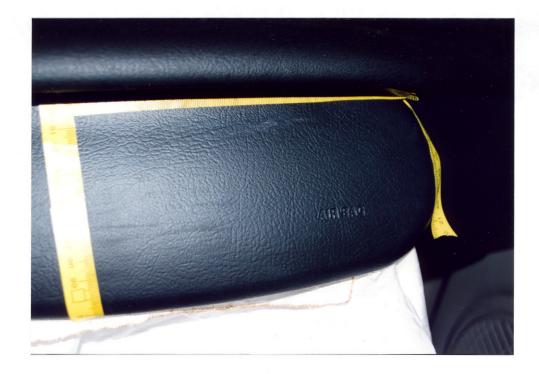
71. Passenger side air bag module flap showing several horizontal scuffs and scratches.

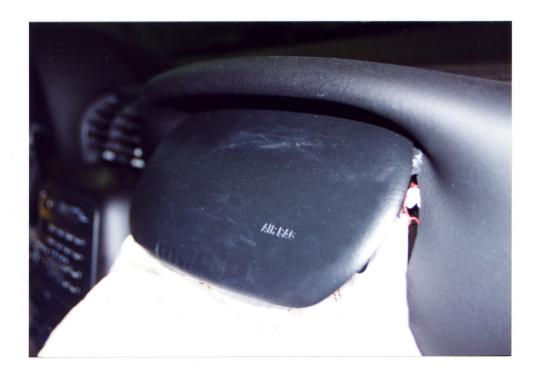
The upper handgrip of the child safety seat was contacted by the passenger side air bag module cover as it rotated upward during the deployment sequence. The expanding air bag contacted the rear surface of the child safety seat propelling it in a rearward rotational motion. This contact event accelerated the safety seat against the child's head which resulted in a depressed fracture of the right parietal-occipital bone, a subgaleal hematoma over the right scalp, contusion of the left fronto temporal area with a small hematoma, and a closed head injury with neurologic deficit. The safety seat's carry handle contacted the right front seat back support. The seat rebounded forward and came to rest on the right front seat cushion.

72. Passenger side air bag module flap showing scuffs along the lower edge consistent with the hand grip of the infant safety seat.

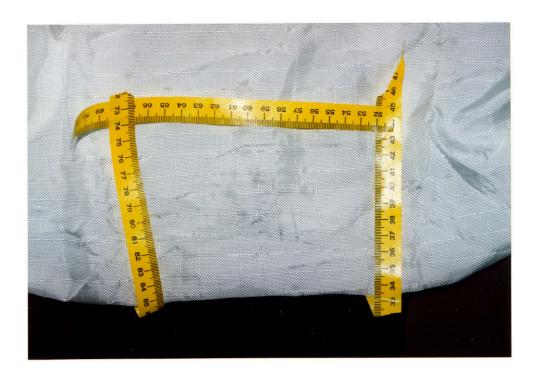
75. Close-up view of the black striated marks on the face of the passenger side air bag.

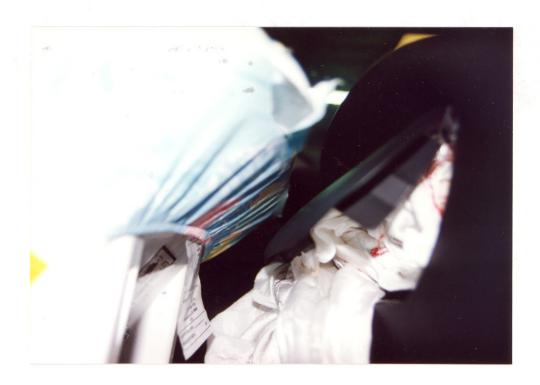
The passenger side mid mount air bag module cover rotated upward as designed during the Supplemental Inflatable Restraint (SIR) actuation sequence and contacted the upper rear surface of the child safety seat's handgrip. This was evident from the vertical transfer/abrasion marks noted on the surface of the air bag module cover which were located along the lower edge of the cover. These transfer marks were consistent in size and shape to the design feature of the handgrip.

88. Close-up overhead view showing the relative position of the infant safety seat with the passenger side air bag module cover.

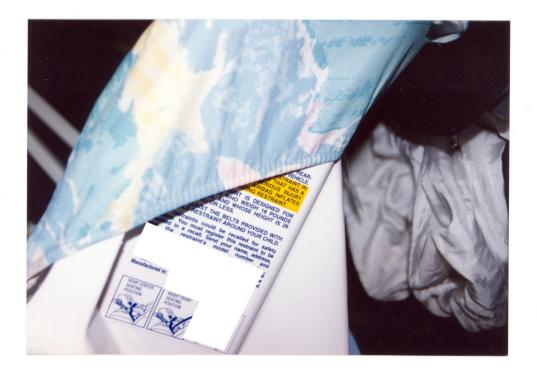
90. Close-up view of the yellow air bag warning label on the infant safety seat which was partially obscured by the seat cover.

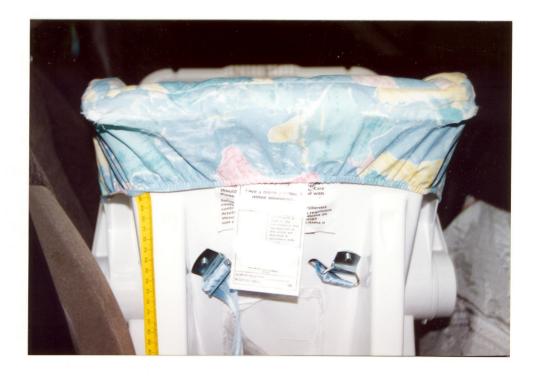
94. View of the upper back of the infant safety seat with the seat cover in place showing tearing of the fabric at the upper right and left corners.

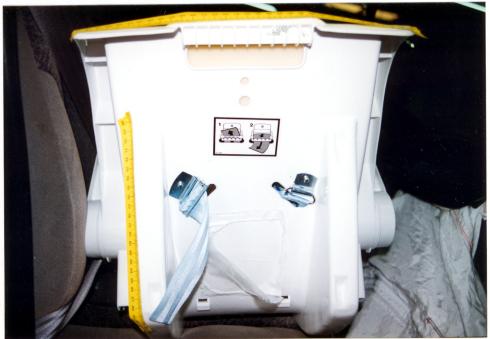
96. View of the back of the infant safety seat with the fabric cover removed showing the fluted area which was consistent with the vertical scuff marks on the lower surface of the air bag module cover.

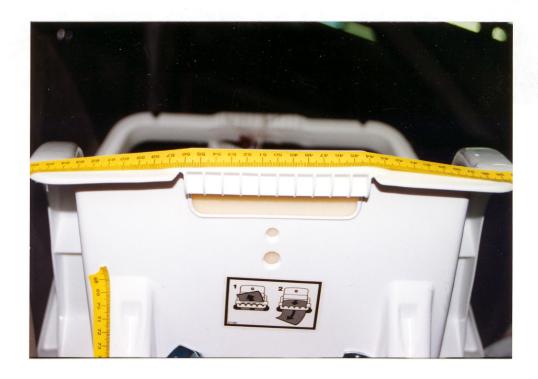
97. Close-up view of the uncovered upper back surface of the infant safety seat showing scuffing across the entire top edge.

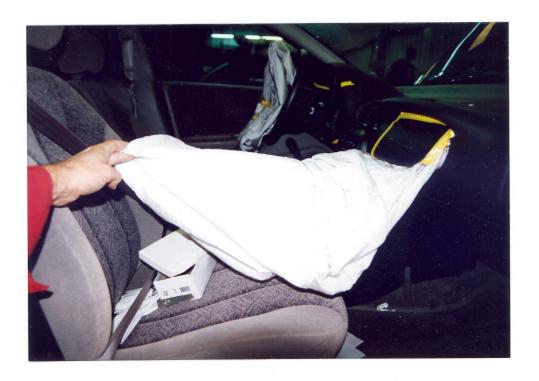
104. Lateral view from the right side of the right front passenger seat and showing the excursion of the passenger side air bag.

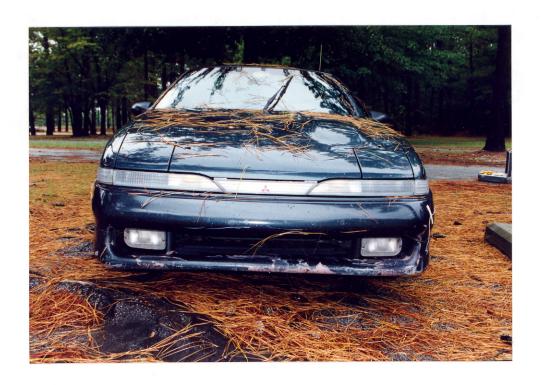
110. Left front corner view of Vehicle #2 showing non-related crash damage to the lower air spoiler.

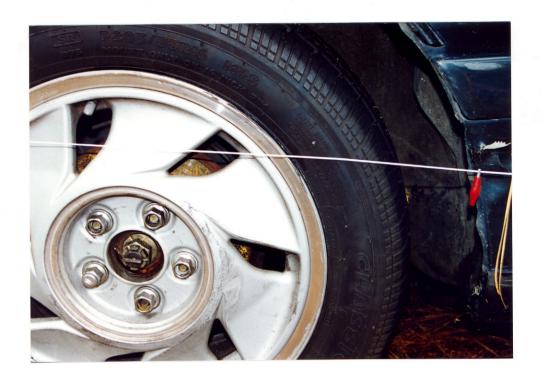
The 1991 Mitsubishi Eclipse sustained direct contact damage along the left side plane which began 16.5 cm (6.5") forward of the left rear axle and extended forward 213.4 cm (84.0"). Maximum lateral displacement of 11.4 cm (4.5") was located 73.7 cm (29.0") forward of the left rear axle. Crush values below the rub strip are listed below:

112. View of the contact damage to the left front wheel, left front fender, and left side door.

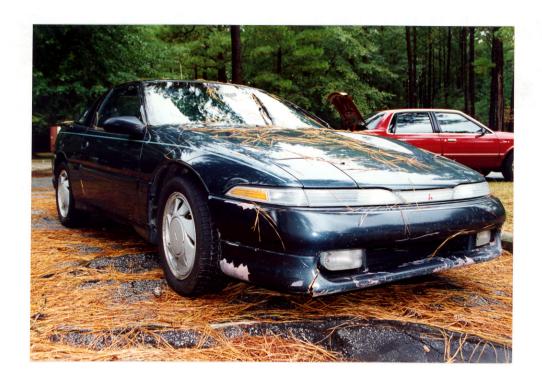
117. View of the right front corner view showing the cracked lower air spoiler.
